**Flood Control Project Maintenance
Levee Inspections**
LMA District Cover Sheet
Spring 2018 Levee Inspection Results

Reclamation District No. 0307 Lisbon

Spring 2018 Levee Inspection Results

Waterway			Bank	Unit Miles
Unit No. 01 Sacramento River			Right	6.56
	Spring (March - May)	Summer (June - August)	(September - November) Fall	Winter (December - February)
Unit Maintenance Rating (Fall Only)				
Date of Inspection	3/6/2018 - 3/6/2018			
DWR Inspector	Dave Torres			
Accompanied By	Pete Dwyer RD 307

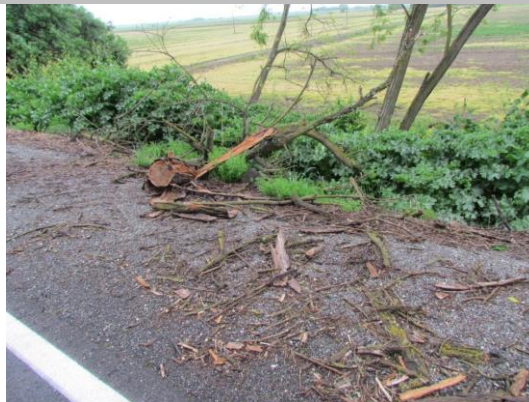
Photo 1 of 1 : SP_2018_RD0307_166_55_20180301_00027.jpg

RD 307 Levee mile 0.09 landside fallen tree on the slope and shoulder.

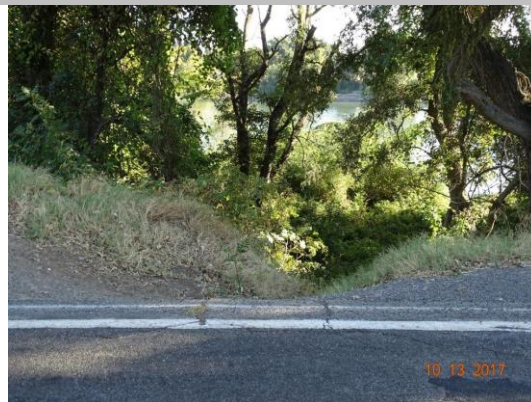
Photo 1 of 1 : SP_2018_RD0307_166_66_20180301_00037.jpg

LM Start	0.20	Rating **	M	Issue No.	66
LM End	0.20	Issue Type +	Ma	Location *	WS
Category	Earthen Levee			GPS Latitude/Longitude	
				Start	End
Item	Slope Stability			38.477977 °	38.477977 °
				-121.546914 °	-121.546914 °
DWR ID	DWR_RD0307_01_f_2017_66				
Comment Code					
S2 : Repair the levee slope damaged by foot traffic and prevent access where possible.					
Inspector Comment					
Foot traffic on waterside slope.

Slope erosion should be repaired and foot traffic stopped.

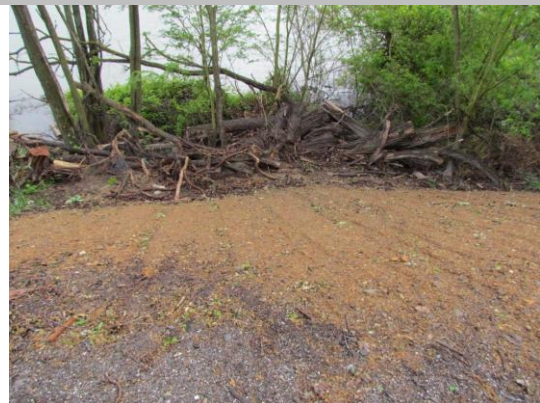
Photo 1 of 1 : SP_2018_RD0307_166_62_20180301_00036.jpg

RD 307 Levee mile 0.35 water side levee slope fallen cut up tree branches and tree sections placed at levee toe.

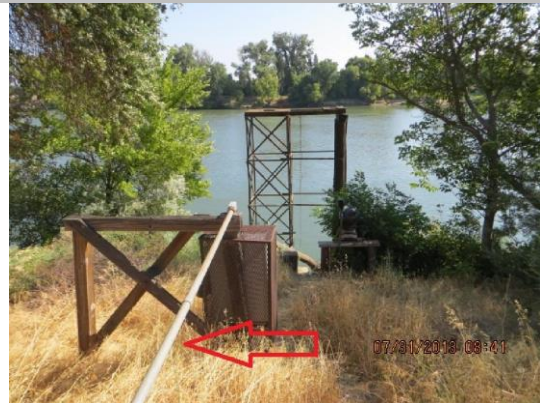
Photo 1 of 3 : UCIP_SP_2018_51632_28733.jpg

Comment Code					
Inspector Comment					
FS_ID:51632 DS_ID:21657 EP_NO: N/A Repair Type: Urgent Crossing Status: Found UCIP Comments: 12/07/2016 Same as last inspection. The bottom portion of the pipe has several holes through the wall. Recommend owner stop use of crossing. Owner will need to coordinate with CVFPB to comply with Title 23 requirements. (O. Magana - DWR UCIP)07/31/2013 Pipe heavily corroded and will likely need replacement if 15-inch pipe sleeved through it needs replacement. Annular space not grouted between two pipes. (W. Wylie - DWR UCIP) FIELD_STRUCT_DESC: 15-inch steel irrigation pipe through the levee, 16.7 feet below the crown. 15-inch pipe sleeved through an existing 20-inch pipe. 20-inch pipe first recorded in the 1964 USACE O&M Manual. Pump missing from abandoned steel pier located on the waterside (WS) toe. Walkway on the waterside (WS) from shoulder to pier missing or abandoned. Concrete U-shaped outlet with flap gate is located on the landside (LS) toe. Service pole located on the LS slope with anchor. [Additional Reference(s): DWR Levee Log, 1990. USACE Sacramento O&M Manual Unit 114, October 1964, (River Mile 48.53)]. FS Date: 12/7/2016

Abandoned wakway and metal pier on WS slope.

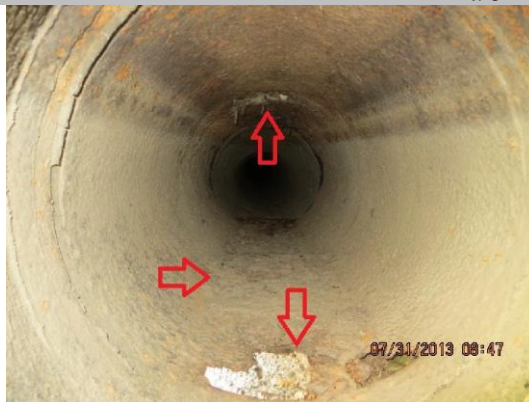
Photo 3 of 3 : UCIP_SP_2018_51632_28731.jpg

Comment Code						
Inspector Comment						
FS_ID:51632 DS_ID:21657 EP_NO: N/A Repair Type: Urgent Crossing Status: Found UCIP Comments: 12/07/2016 Same as last inspection. The bottom portion of the pipe has several holes through the wall. Recommend owner stop use of crossing. Owner will need to coordinate with CVFPB to comply with Title 23 requirements. (O. Magana - DWR UCIP)07/31/2013 Pipe heavily corroded and will likely need replacement if 15-inch pipe sleeved through it needs replacement. Annular space not grouted between two pipes. (W. Wylie - DWR UCIP) FIELD_STRUCT_DESC: 15-inch steel irrigation pipe through the levee, 16.7 feet below the crown. 15-inch pipe sleeved through an existing 20-inch pipe. 20-inch pipe first recorded in the 1964 USACE O&M Manual. Pump missing from abandoned steel pier located on the waterside (WS) toe. Walkway on the waterside (WS) from shoulder to pier missing or abandoned. Concrete U-shaped outlet with flap gate is located on the landside (LS) toe. Service pole located on the LS slope with anchor. [Additional Reference(s): DWR Levee Log, 1990. USACE Sacramento O&M Manual Unit 114, October 1964, (River Mile 48.53)]. FS Date: 12/7/2016

Holes and corrosion shown inside 15-inch pipe sleeved through this pipe.

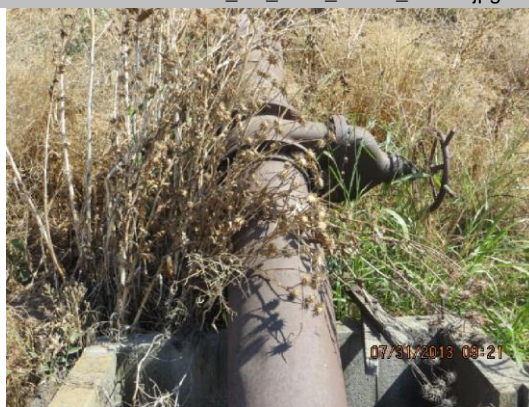
Photo 2 of 3 : UCIP_SP_2018_16764_28763.jpg

Comment Code					
Inspector Comment					
FS_ID:16764 DS_ID:21659 EP_NO: 8012 Repair Type: Non-Urgent Crossing Status: Found UCIP Comments: Pipe rusted through at outlet on LS of shutoff valve. This may be good indicator or corrosion throughout pipe. This is a good candidate for video inspection. FIELD_STRUCT_DESC: 1 of 2: 20-inch steel irrigation pipe through the levee, 7.4 feet below the crown. Walkway from the waterside (WS) shoulder to pump on pile structure in stream. Distribution box and gate valve at the landside (LS) toe. Service pole on the LS. (Permit No. 8012, 1972 - Eula Glide Elliott). [Additional Reference(s): DWR Levee Log, 1990. USACE Sacramento O&M Manual 114, April 1959, (RM 48.53)]. FS Date: 7/31/2013

Pipe, gate valve, and concrete distribution box on LS toe.

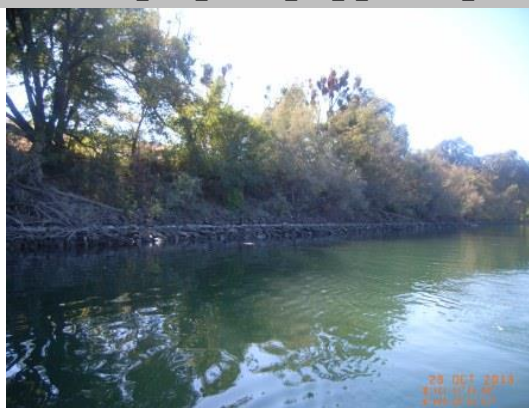
Photo 1 of 1 : SP_2018_RD0307_166_1_20180301_00001.jpg

LM Start	1.17	Rating **	M	Issue No.	1
LM End	1.31	Issue Type +	Ma	Location *	WS
Category	Supplemental			GPS Latitude/Longitude	
				Start	End
Item	2015 USACE Erosion Survey, DRAFT			38.473059 °	38.473082 °
				-121.530988 °	-121.528437 °
DWR ID	DWR_RD0307_01_s_2016_1				
Comment Code					
Inspector Comment					
2012 - Bank is slowly eroding, old rock protection starting to unravel. 2015: No observed changes. [2015 Site ID: SAC_48-6_R]

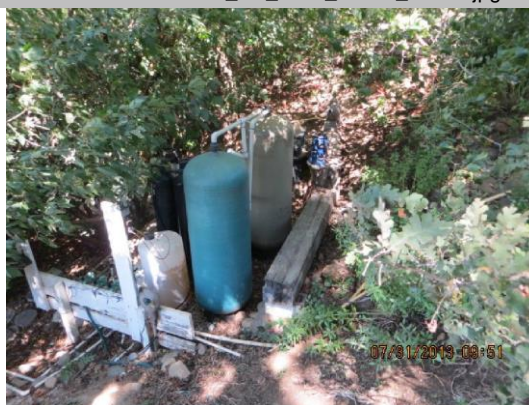
Photo 1 of 3 : UCIP_SP_2018_17105_29207.jpg

LM Start	1.62	Rating **	M	Issue No.	134
LM End	1.62	Issue Type +	En	Location *	
Category	Supplemental			GPS Latitude/Longitude	
				Start	End
Item	DWR UCIP Field Study			38.473129 °	38.473129 °
				-121.522717 °	-121.522717 °
DWR ID					
Comment Code					
Inspector Comment					
FS_ID:17105 DS_ID:24017 EP_NO: N/A Repair Type: Non-Urgent Crossing Status: Found UCIP Comments: No permit identified for crossing or boat dock/steel ramp. FIELD_STRUCT_DESC: 2 of 2: 1.5-inch polyvinyl chloride (PVC) irrigation pipe through the levee, 2 feet below the crown. Metal walkway and pier on the waterside (WS) slope. Possible pump, filter, and tanks on the landside (LS) slope. FS Date: 7/31/2013

Possible pump and filter station on LS slope.

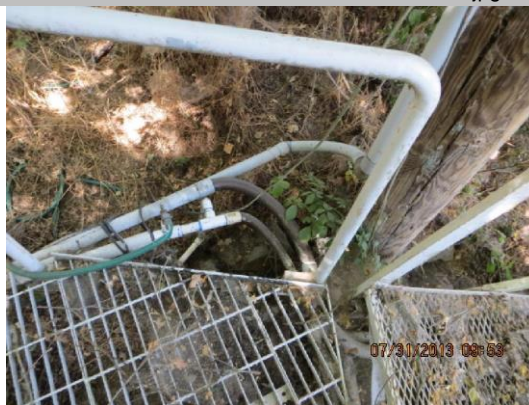
Photo 3 of 3 : UCIP_SP_2018_17105_29205.jpg

Pipes visible under walkway on WS slope.

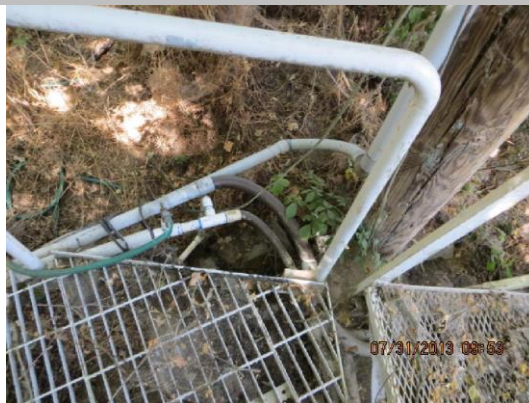
Photo 3 of 3 : UCIP_SP_2018_17106_29208.jpg

Pipes visible under metal ramp on WS slope.

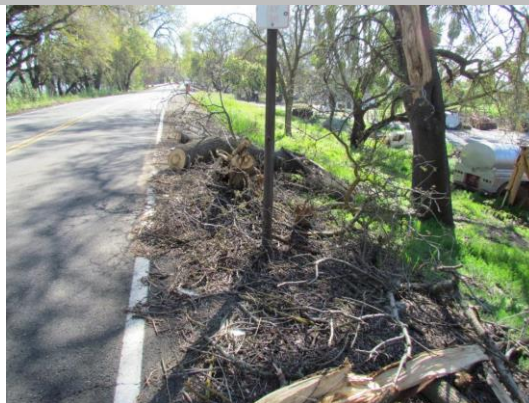
Photo 2 of 3 : SP_2018_RD0307_166_73_20180301_00039.jpg

Looking downstream toward levee mile 1.87 fallen tree on shoulder.

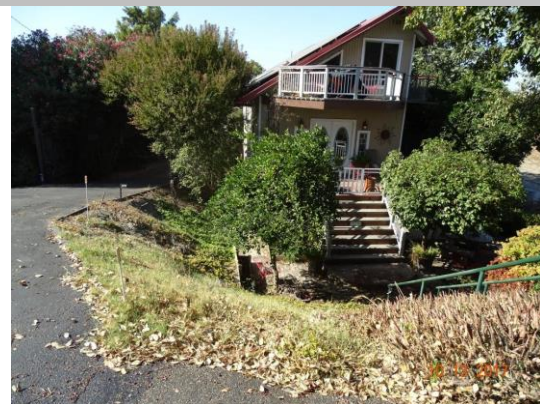
Photo 1 of 1 : SP_2018_RD0307_166_96_20180301_00050.jpg

LM Start	2.59	Rating **	M	Issue No.	96
LM End	2.59	Issue Type +	En	Location *	LS
Category	Earthen Levee		GPS Latitude/Longitude		
			Start	End	
Item	Encroachments		38.469358 °	38.469358 °	
			-121.506362 °	-121.506362 °	
DWR ID	DWR_RD0307_01_f_2017_96				
Comment Code					
TR : Tree or limb					
Inspector Comment					
Remove fruit tree.

Remove fruit tree.

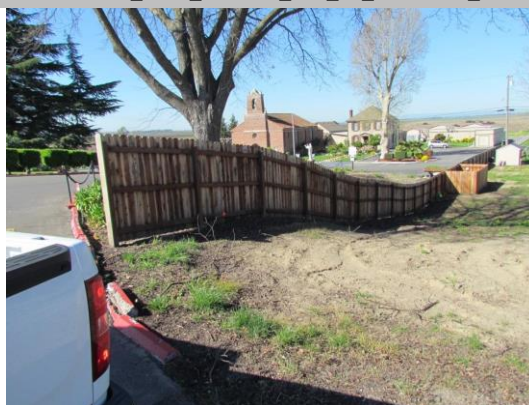
Photo 1 of 1 : SP_2018_RD0307_166_79_20180301_00041.jpg

Looking down the landside slope and shoulder of levee mile 3.19 new replacement of a solid wall wooden fence. No change.

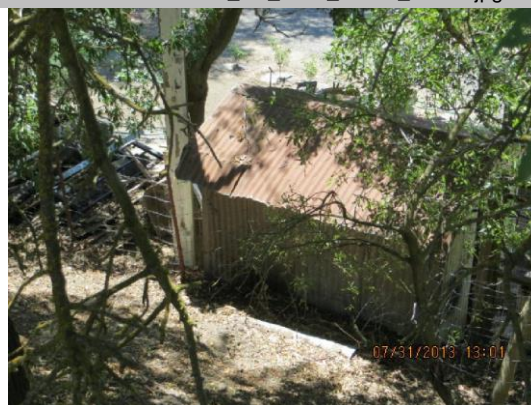
Photo 1 of 2 : UCIP_SP_2018_16843_28881.jpg

Pumphouse on LS toe. No access due to fence along toe.

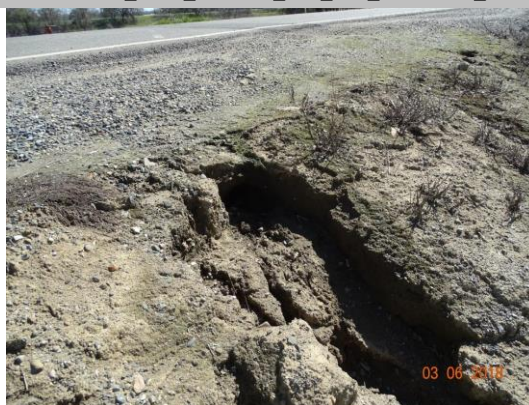
Photo 1 of 2 : SP_2018_RD0307_166_128_20180308_00143.jpg

Erosion rodent hole landside looking east.

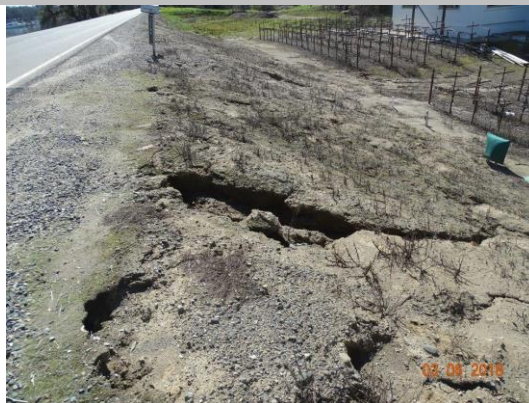
Photo 2 of 2 : SP_2018_RD0307_166_128_20180308_00144.jpg

Erosion rodent hole landside looking south.

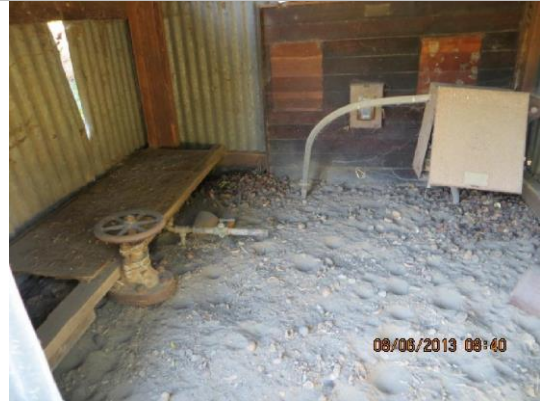
Photo 3 of 3 : UCIP_SP_2018_51446_29259.jpg

Gate valve in pumphouse on LS toe. pumphouse filled with soil.

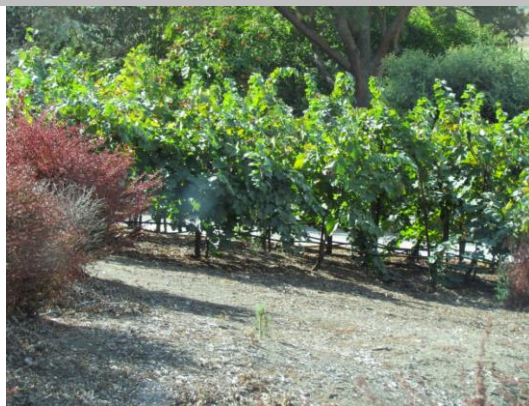
Photo 1 of 1 : SP_2018_RD0307_166_27_20180301_00008.jpg

Unwanted grapes placed on levee slope, these grapes has been reported to both district and CVFPB. No permit.

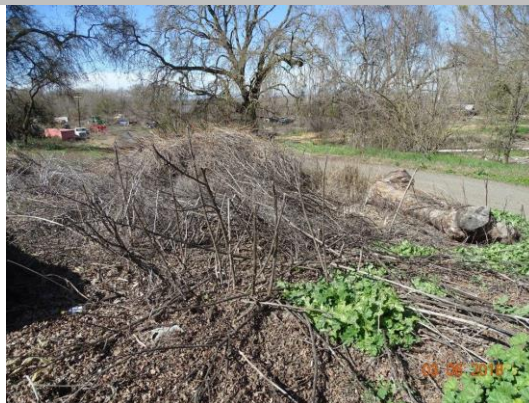
Photo 1 of 1 : SP_2018_RD0307_166_114_20180308_00141.jpg

Vegetation landside looking southwest.

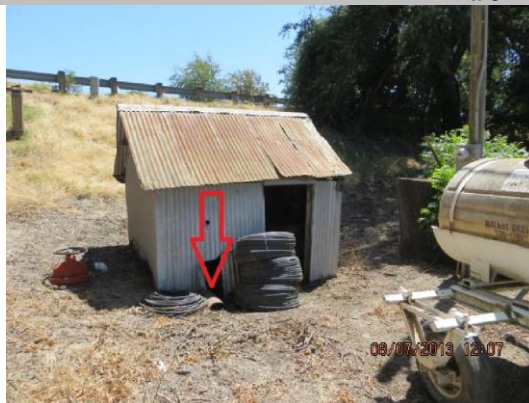
Photo 3 of 3 : UCIP_SP_2018_17385_29487.jpg

Pipe cut and open on LS of pumphouse.

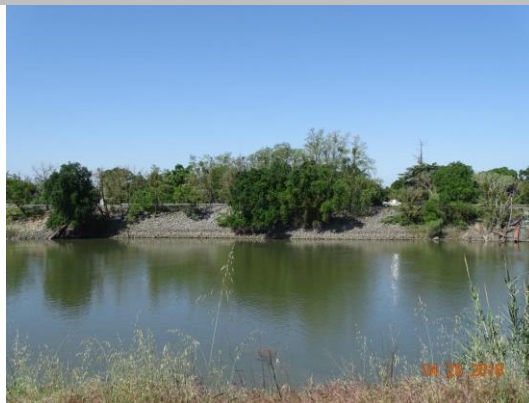
Photo 2 of 2 : SP_2018_RD0307_166_107_20180425_00146.jpg

RD307 Lisbon Unit 1 Issue 107 LM6.42-6.55 Erosion repaired picture taken from LB looking west.
